PROPERTY INSPECTION REPORT:

Residential Building:

Complying with Australian Standard AS4349.1-2007 – Part 1 Pre-purchase Inspections –Residential Buildings

Date of Inspection: --/09/12 Job Number: ---/2012 Inspector: Andrew Walton-Smith

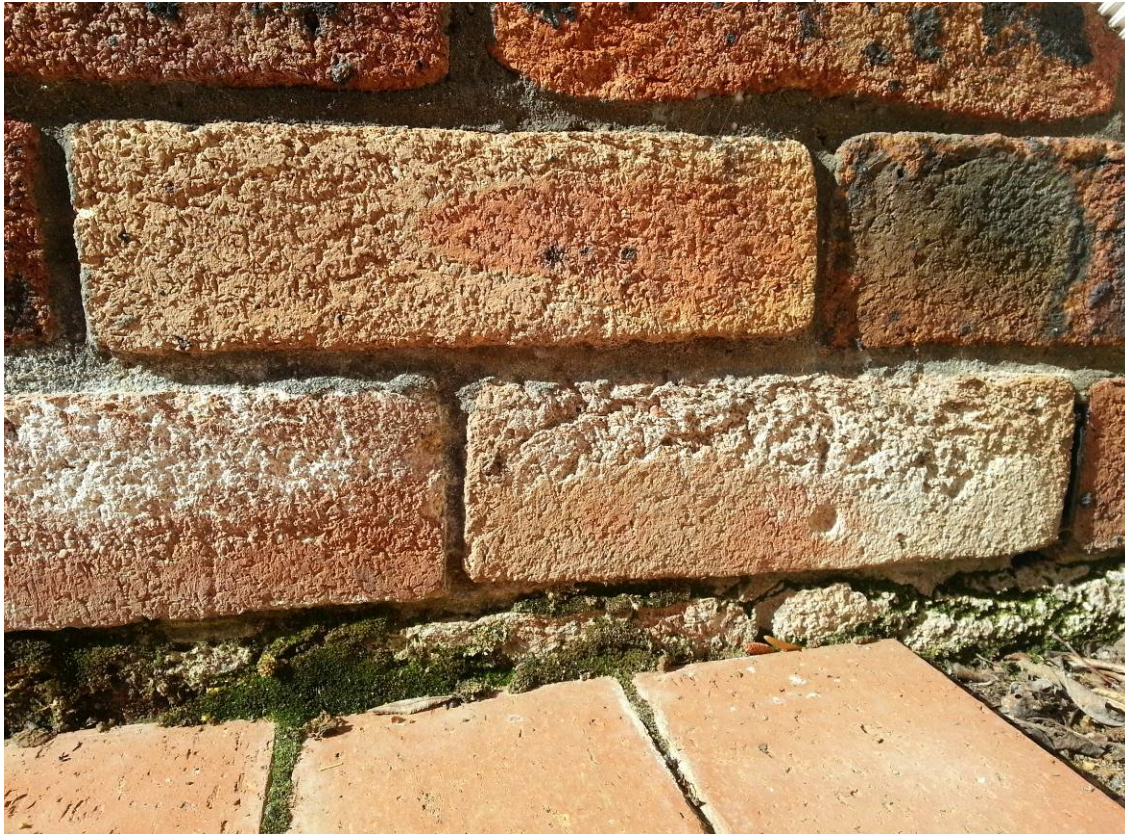
There is minor fretting of the brickwork and efflorescence (Leaching salts) to the left hand side of the property adjacent to the hot water unit (**Photo: 1**).

Photo 1: Minor fretting of the brickwork and efflorescence.

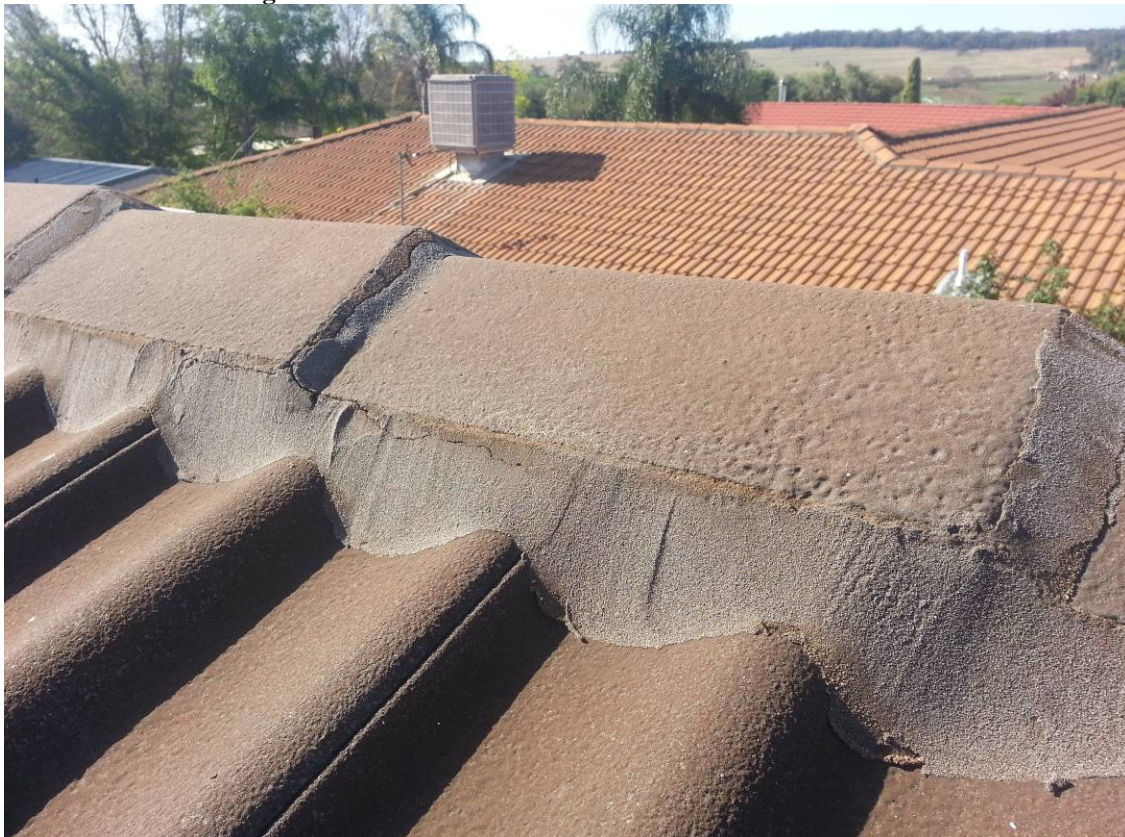
There is hairline to 2mm cracking to the bedding and pointing of the ridge, hip and barge tiles in various locations (Photo: 2).

Photo 2: Example of hairline cracking to the pointing.

Tiled Roof: NB: Bedding and pointing to tiles roofs is a common issue and is part of routine maintenance and should be redone approximately every 10 years.

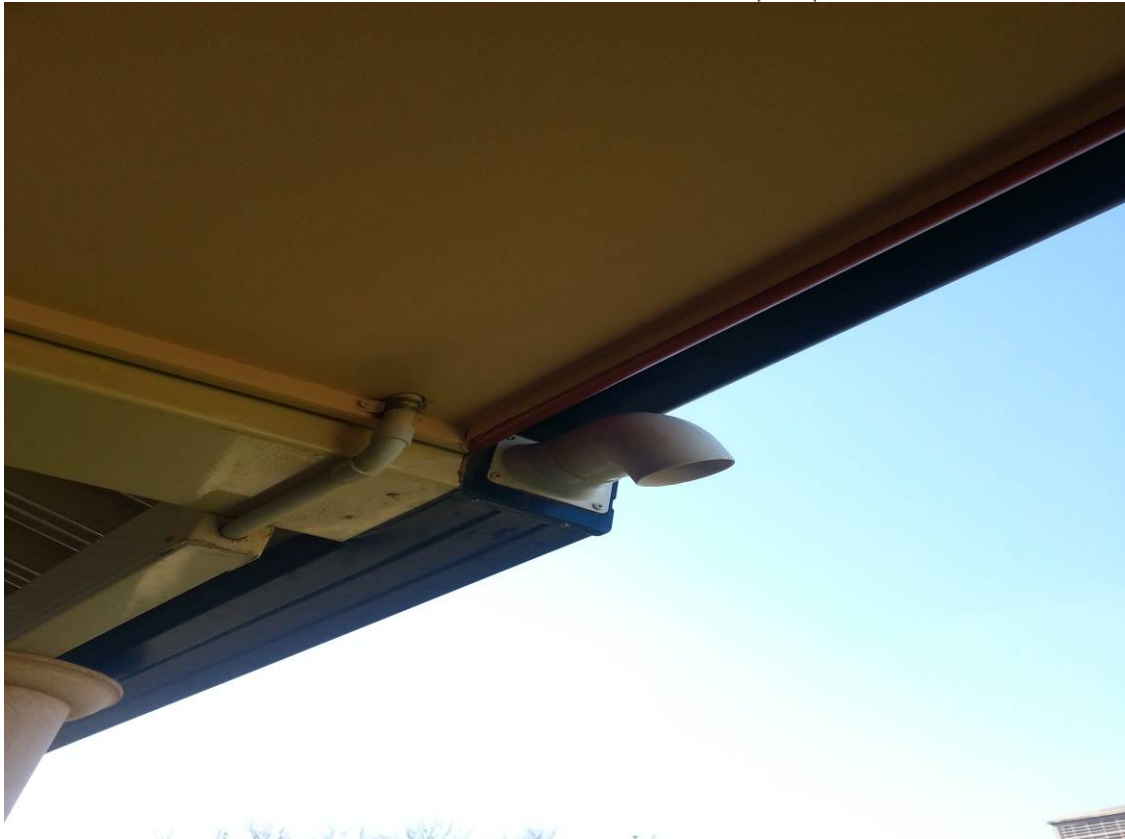
There is no downpipe to the front right hand corner, only a short PVC opening to the guttering which is not ideal (Photo: 3).

Photo 3: Downpipe opening to the pergola.

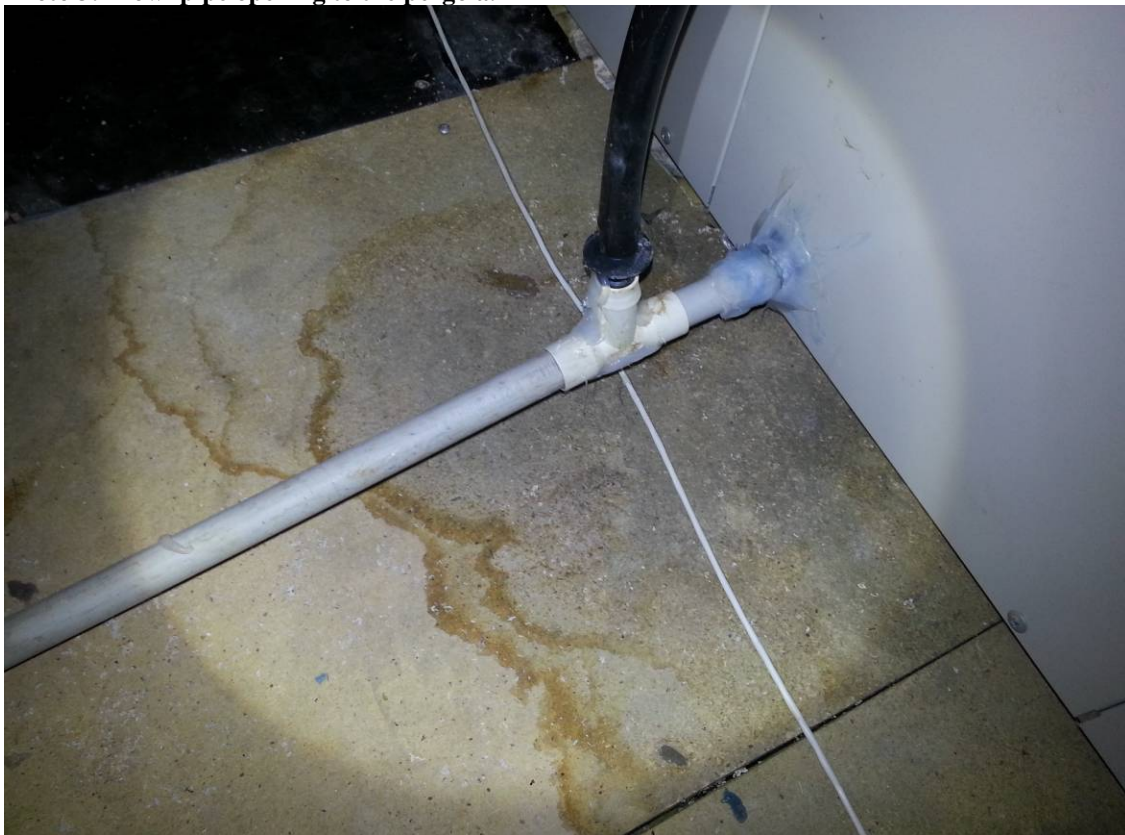
Trusses: Yes: There is some water staining beneath the water runoff line to the ducted heating system (**Photo: 4**).

Photo 4: Water staining beneath water runoff line.
